Part No. 216109-A  
May 2004

# **Release Notes for the Nortel Networks Wireless LAN 2220/ 2221 Access Point Software Release 1.3.0.0**

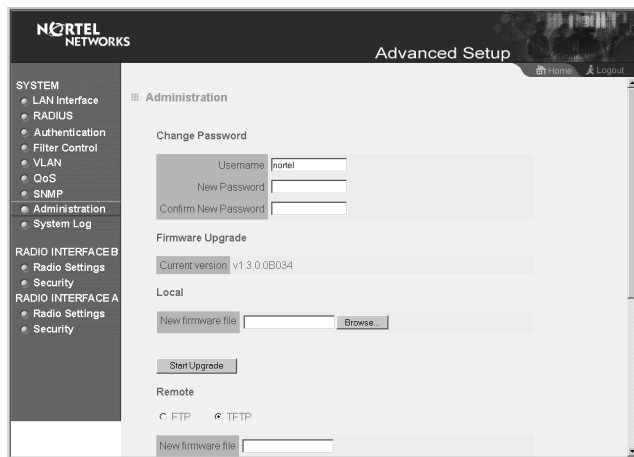
**Figure 1** Administration screen (1 of 2)

- 1 Open the Advanced Setup > Administration screen (see [Figure 1](#) and [Figure 2](#)).

- 1 Open the Advanced Setup > Administration screen (see [Figure 1](#) and [Figure 2](#)).

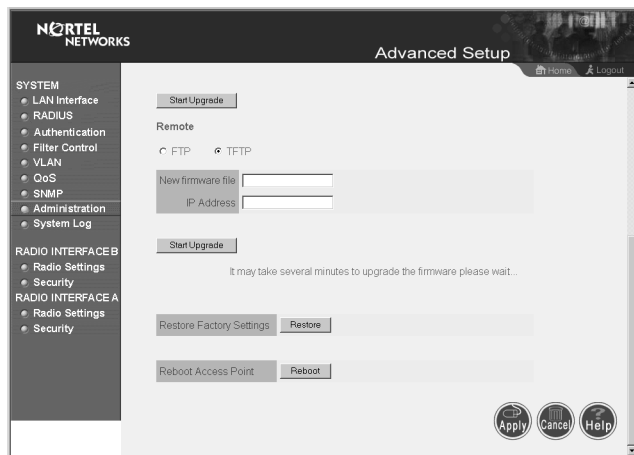
**Figure 2** Administration screen (2 of 2)

- 2 Click “Browse” and locate the new software image file.
- 3 Click “Start Upgrade” to begin the upgrade process. The new software image file will be downloaded to the Access Point 2220/2221.
- 4 Follow the onscreen instructions and click “Reboot” when the file has been copied to the Access Point 2220/2221.
